An Taisce
The National Trust for Ireland

Buildings at Risk

November 2014

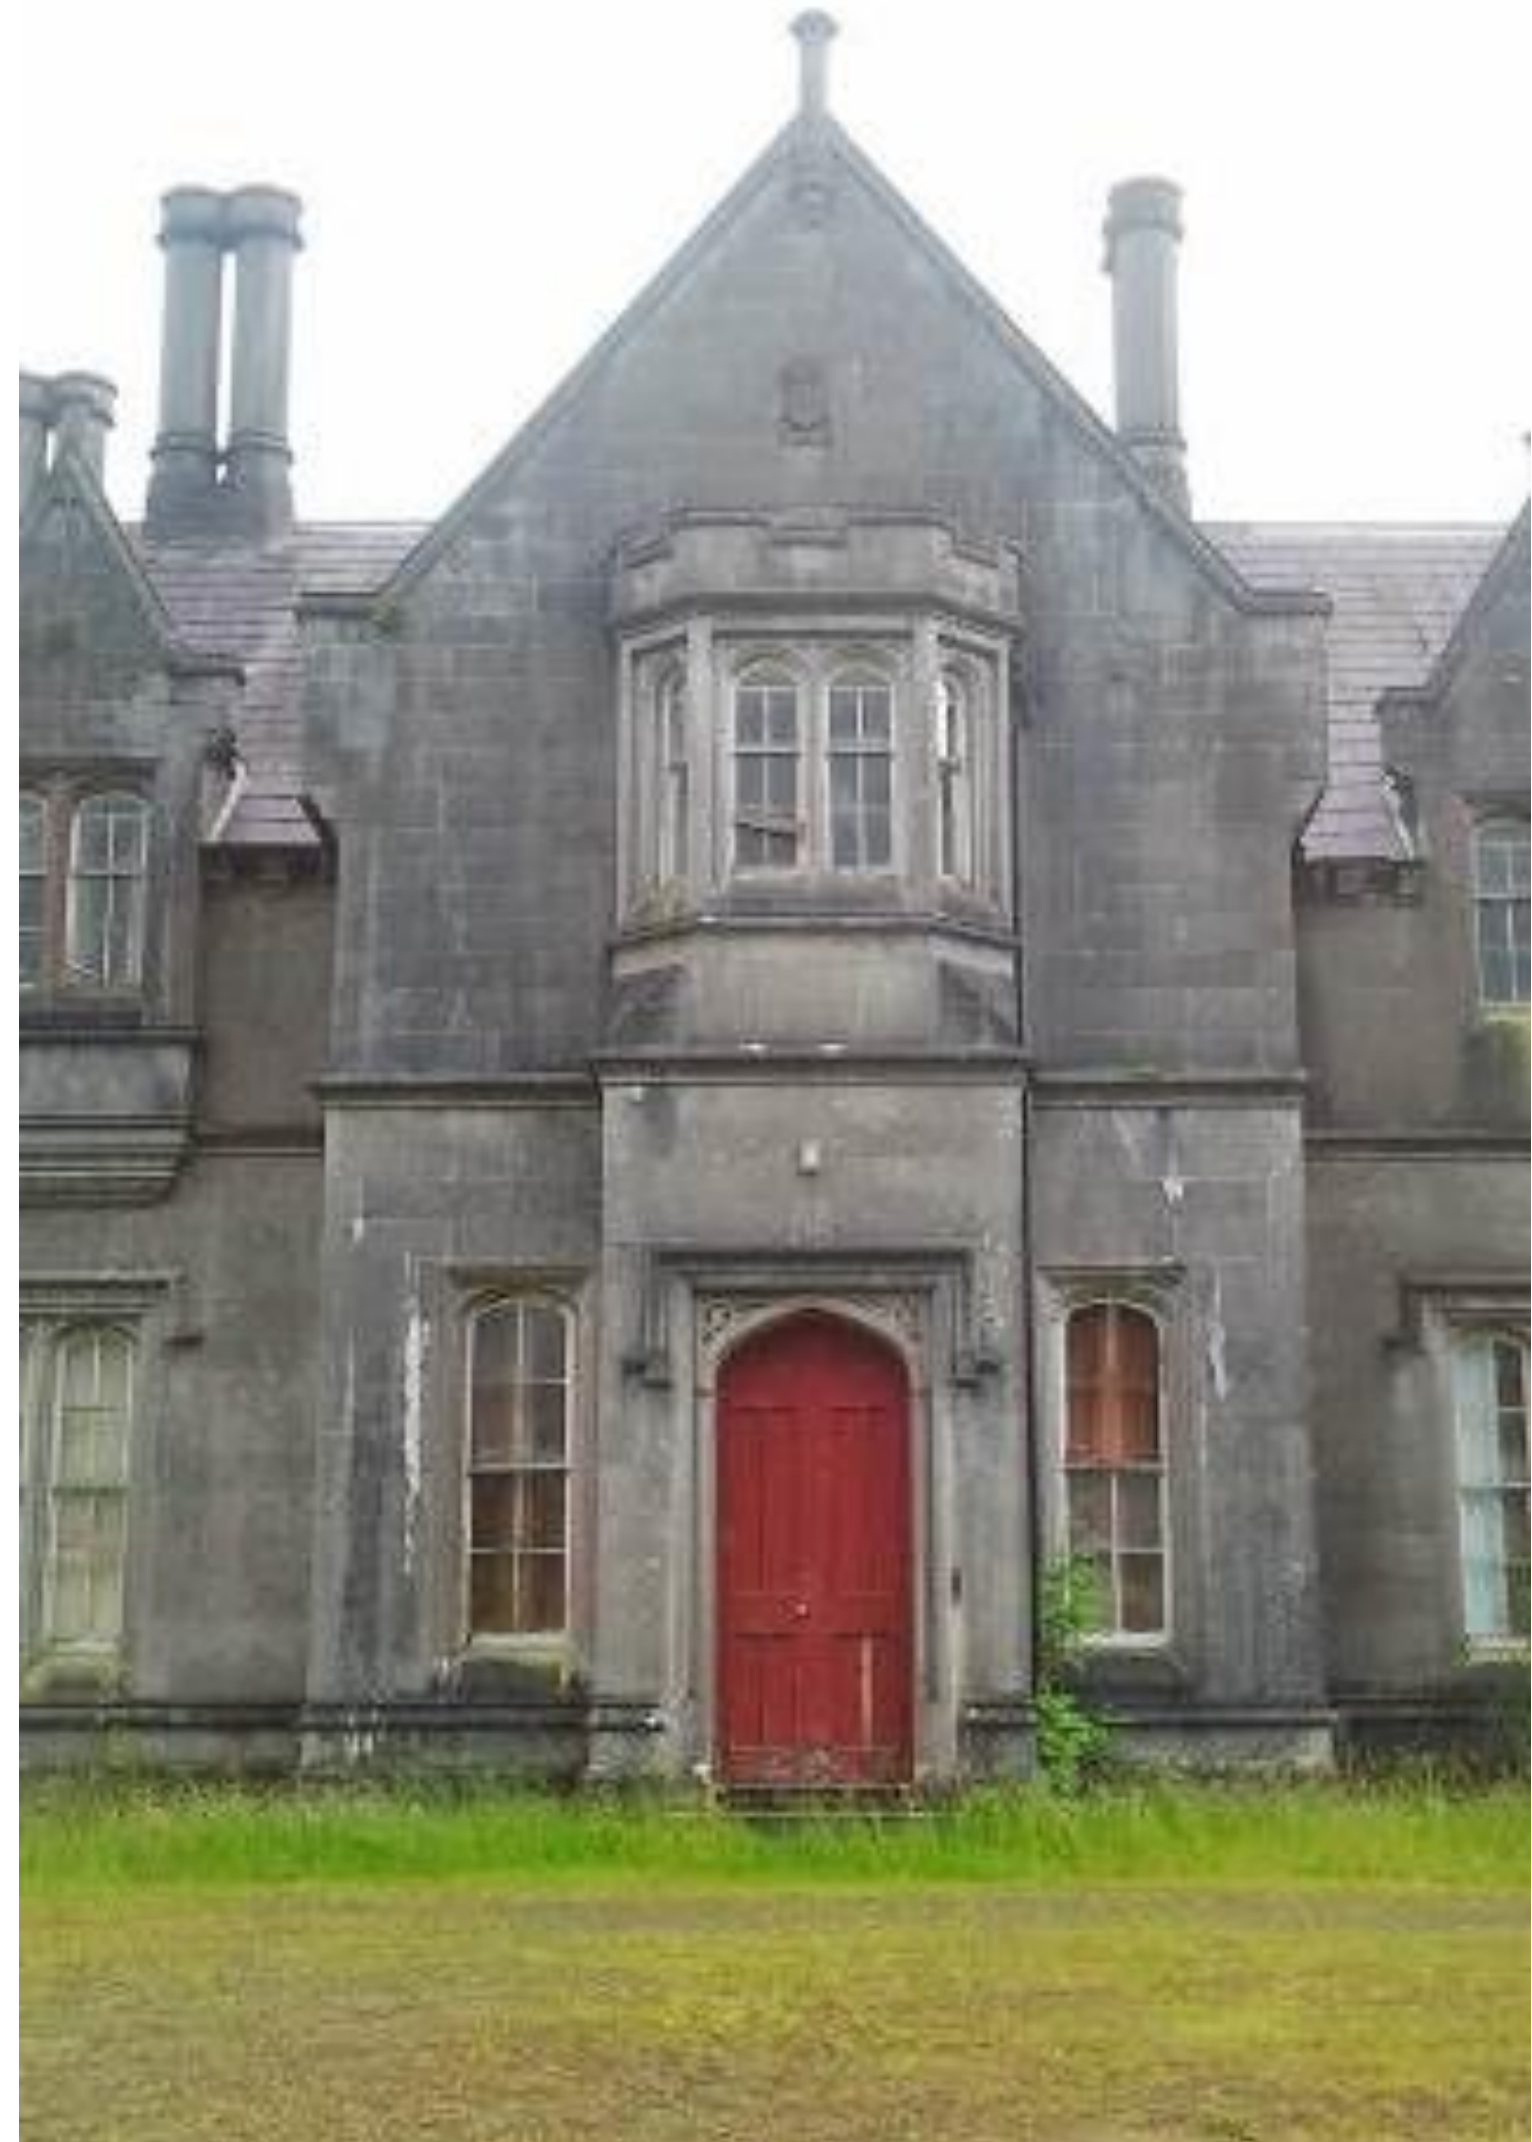
Carstown House

Vacant with no identified new use	X
Suffering from neglect and/or poor maintenance	X
Suffering from structural problems	
Fire damaged	
Threatened with demolition	
Ruin which is poorly maintained

Condition of Structure	Poor
Level of Risk	High

This building has been vacant for a number of years and does not appear to be maintained. Most of the external fabric remains, but there are obvious signs of deterioration, particularly water penetration, slipped slates and vegetation growth. There is no immediate danger of collapse but the condition is such that unless urgent remedial works are carried out the building will sharply deteriorate.

Carstown is a rare surviving gabled house. The building is of national significance in the National Inventory of Architectural Heritage given its 'hybrid of building styles and intact seventeenth-century interior'. The building contains architectural features such as large dormers, a '1612' date stone and Cromwellian chimneystack. Most of the windows are currently filled with bricks. This building urgently requires new uses to be identified to prevent further deterioration of its character.

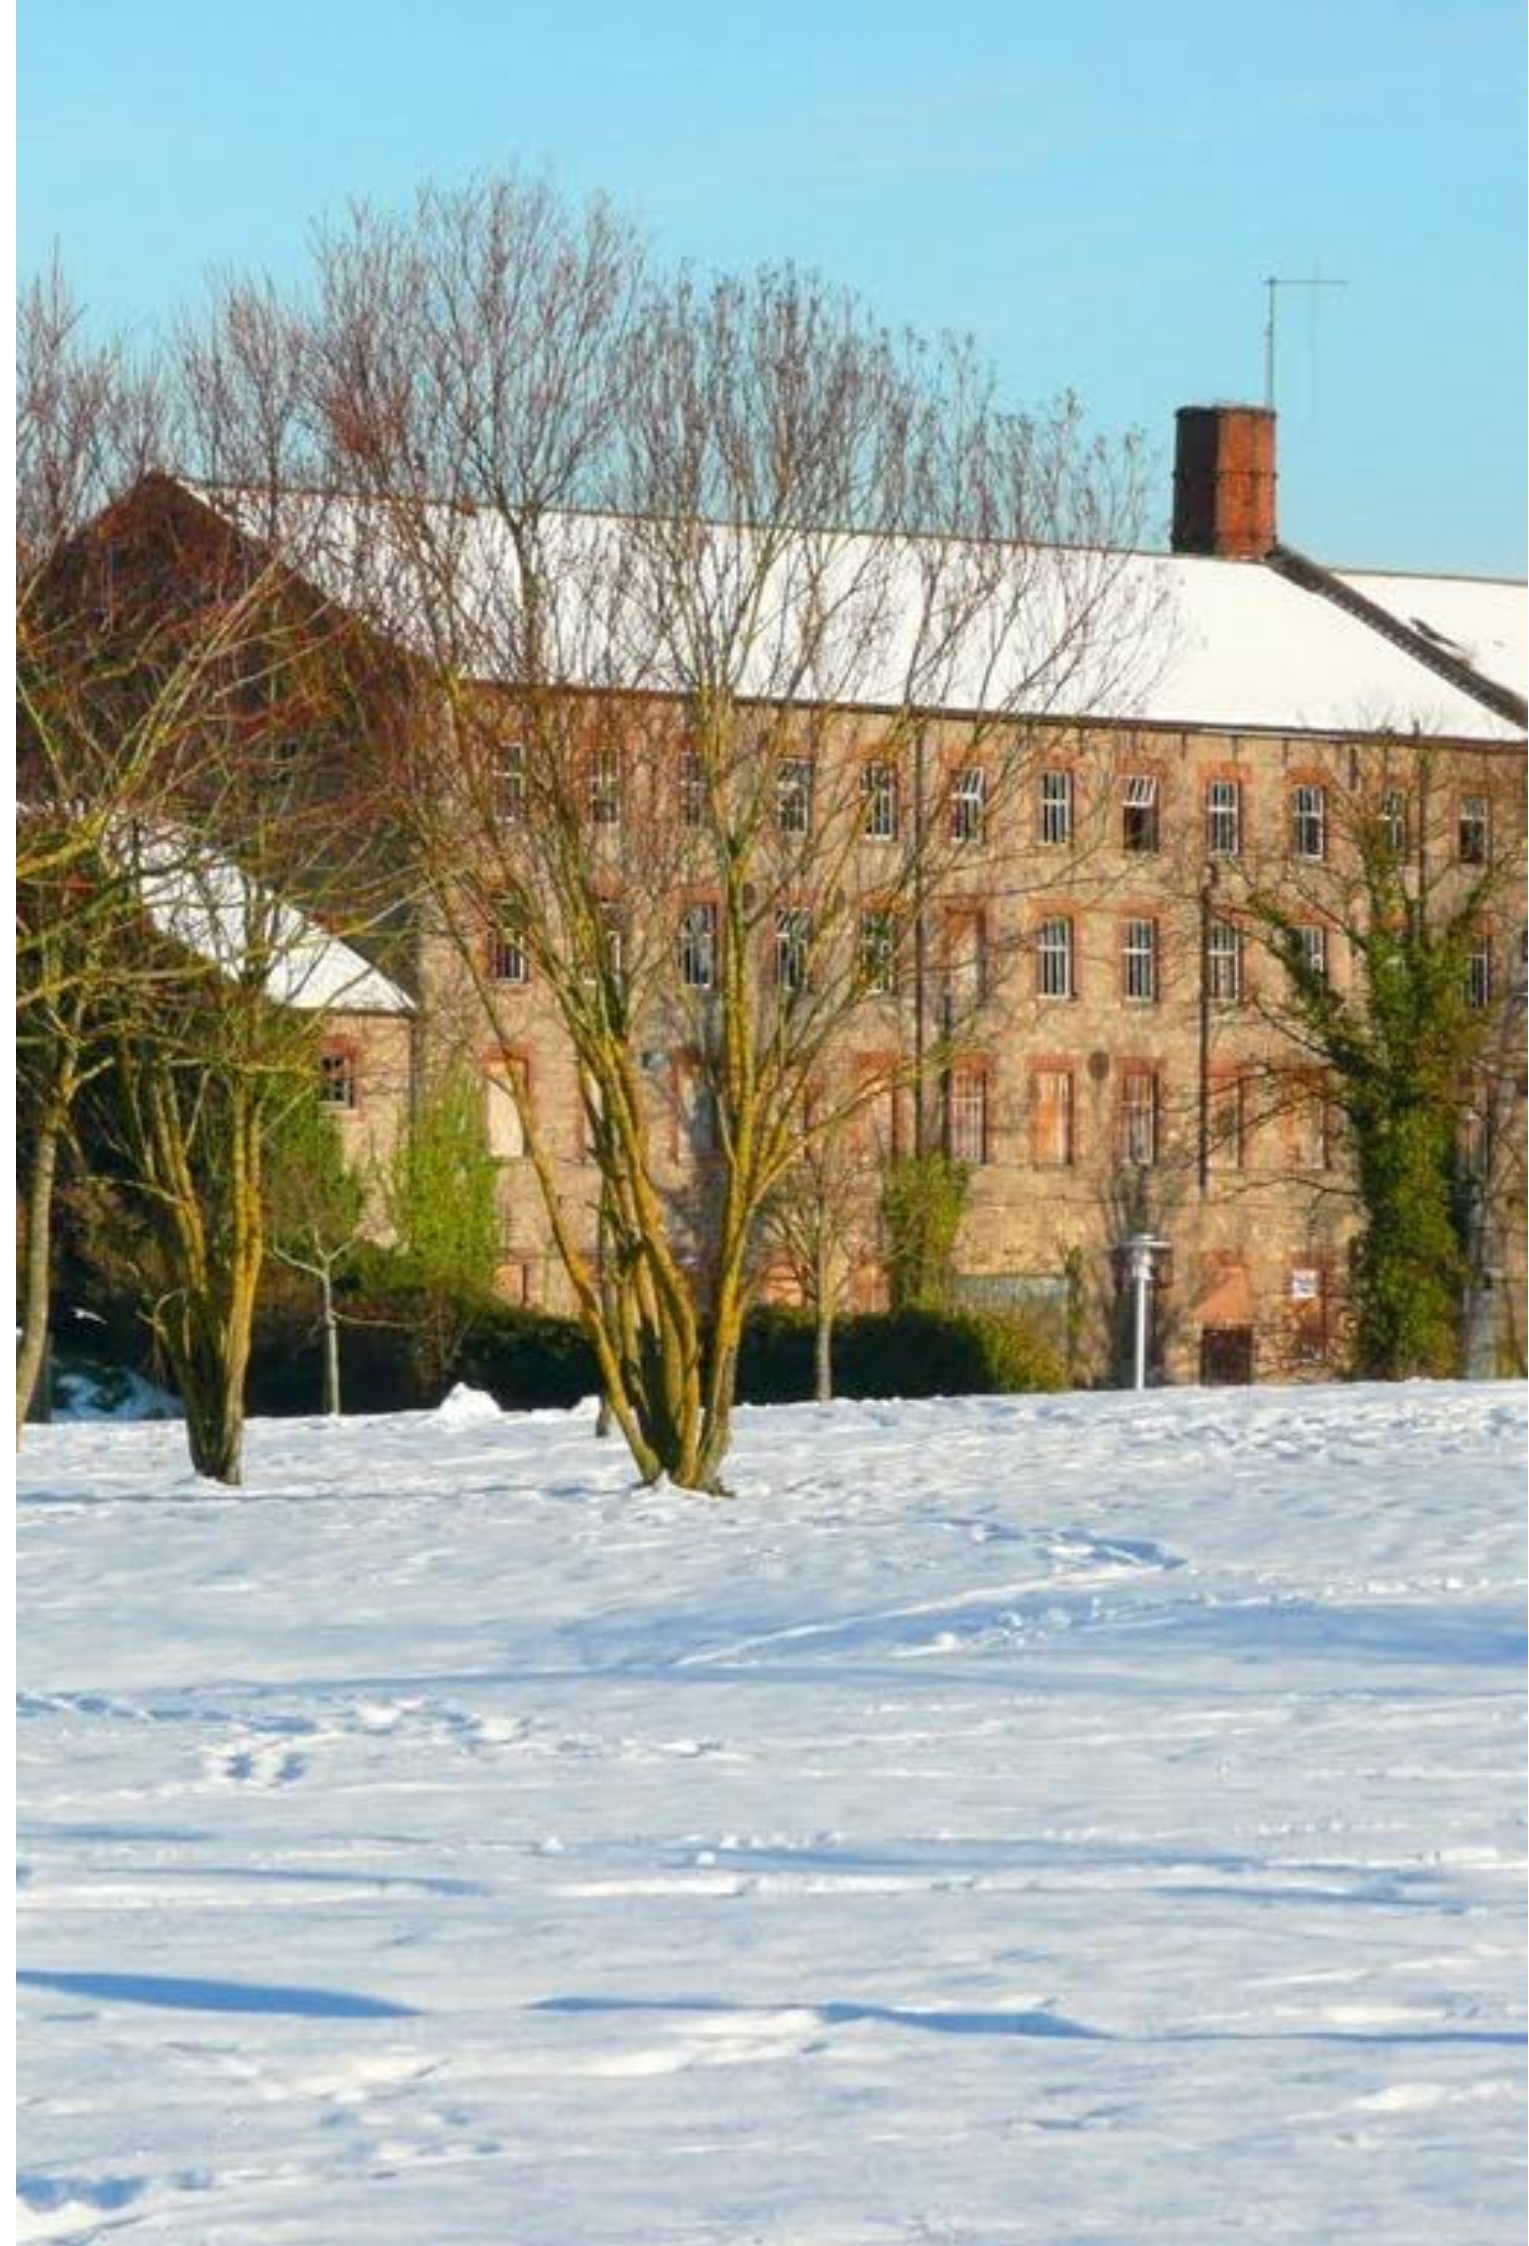
Stephenstown House

Vacant with no identified new use	
Suffering from neglect and/or poor maintenance	X
Suffering from structural problems	
Fire damaged	
Threatened with demolition	
Ruin which is poorly maintained	X

Condition of Structure	Ruinous
Level of Risk	High

The building is a roofless shell. None of the original fabric remains other than the external walls. It is suffering from structural problems that could lead to full or partial collapse, and there is an immediate threat of further deterioration.

A derelict shell of house built 1780 for Matthew Fortescue with later extensions. The house was occupied until the 1970s. The structure is of significant historic importance and requires conservation works to prevent further deterioration.

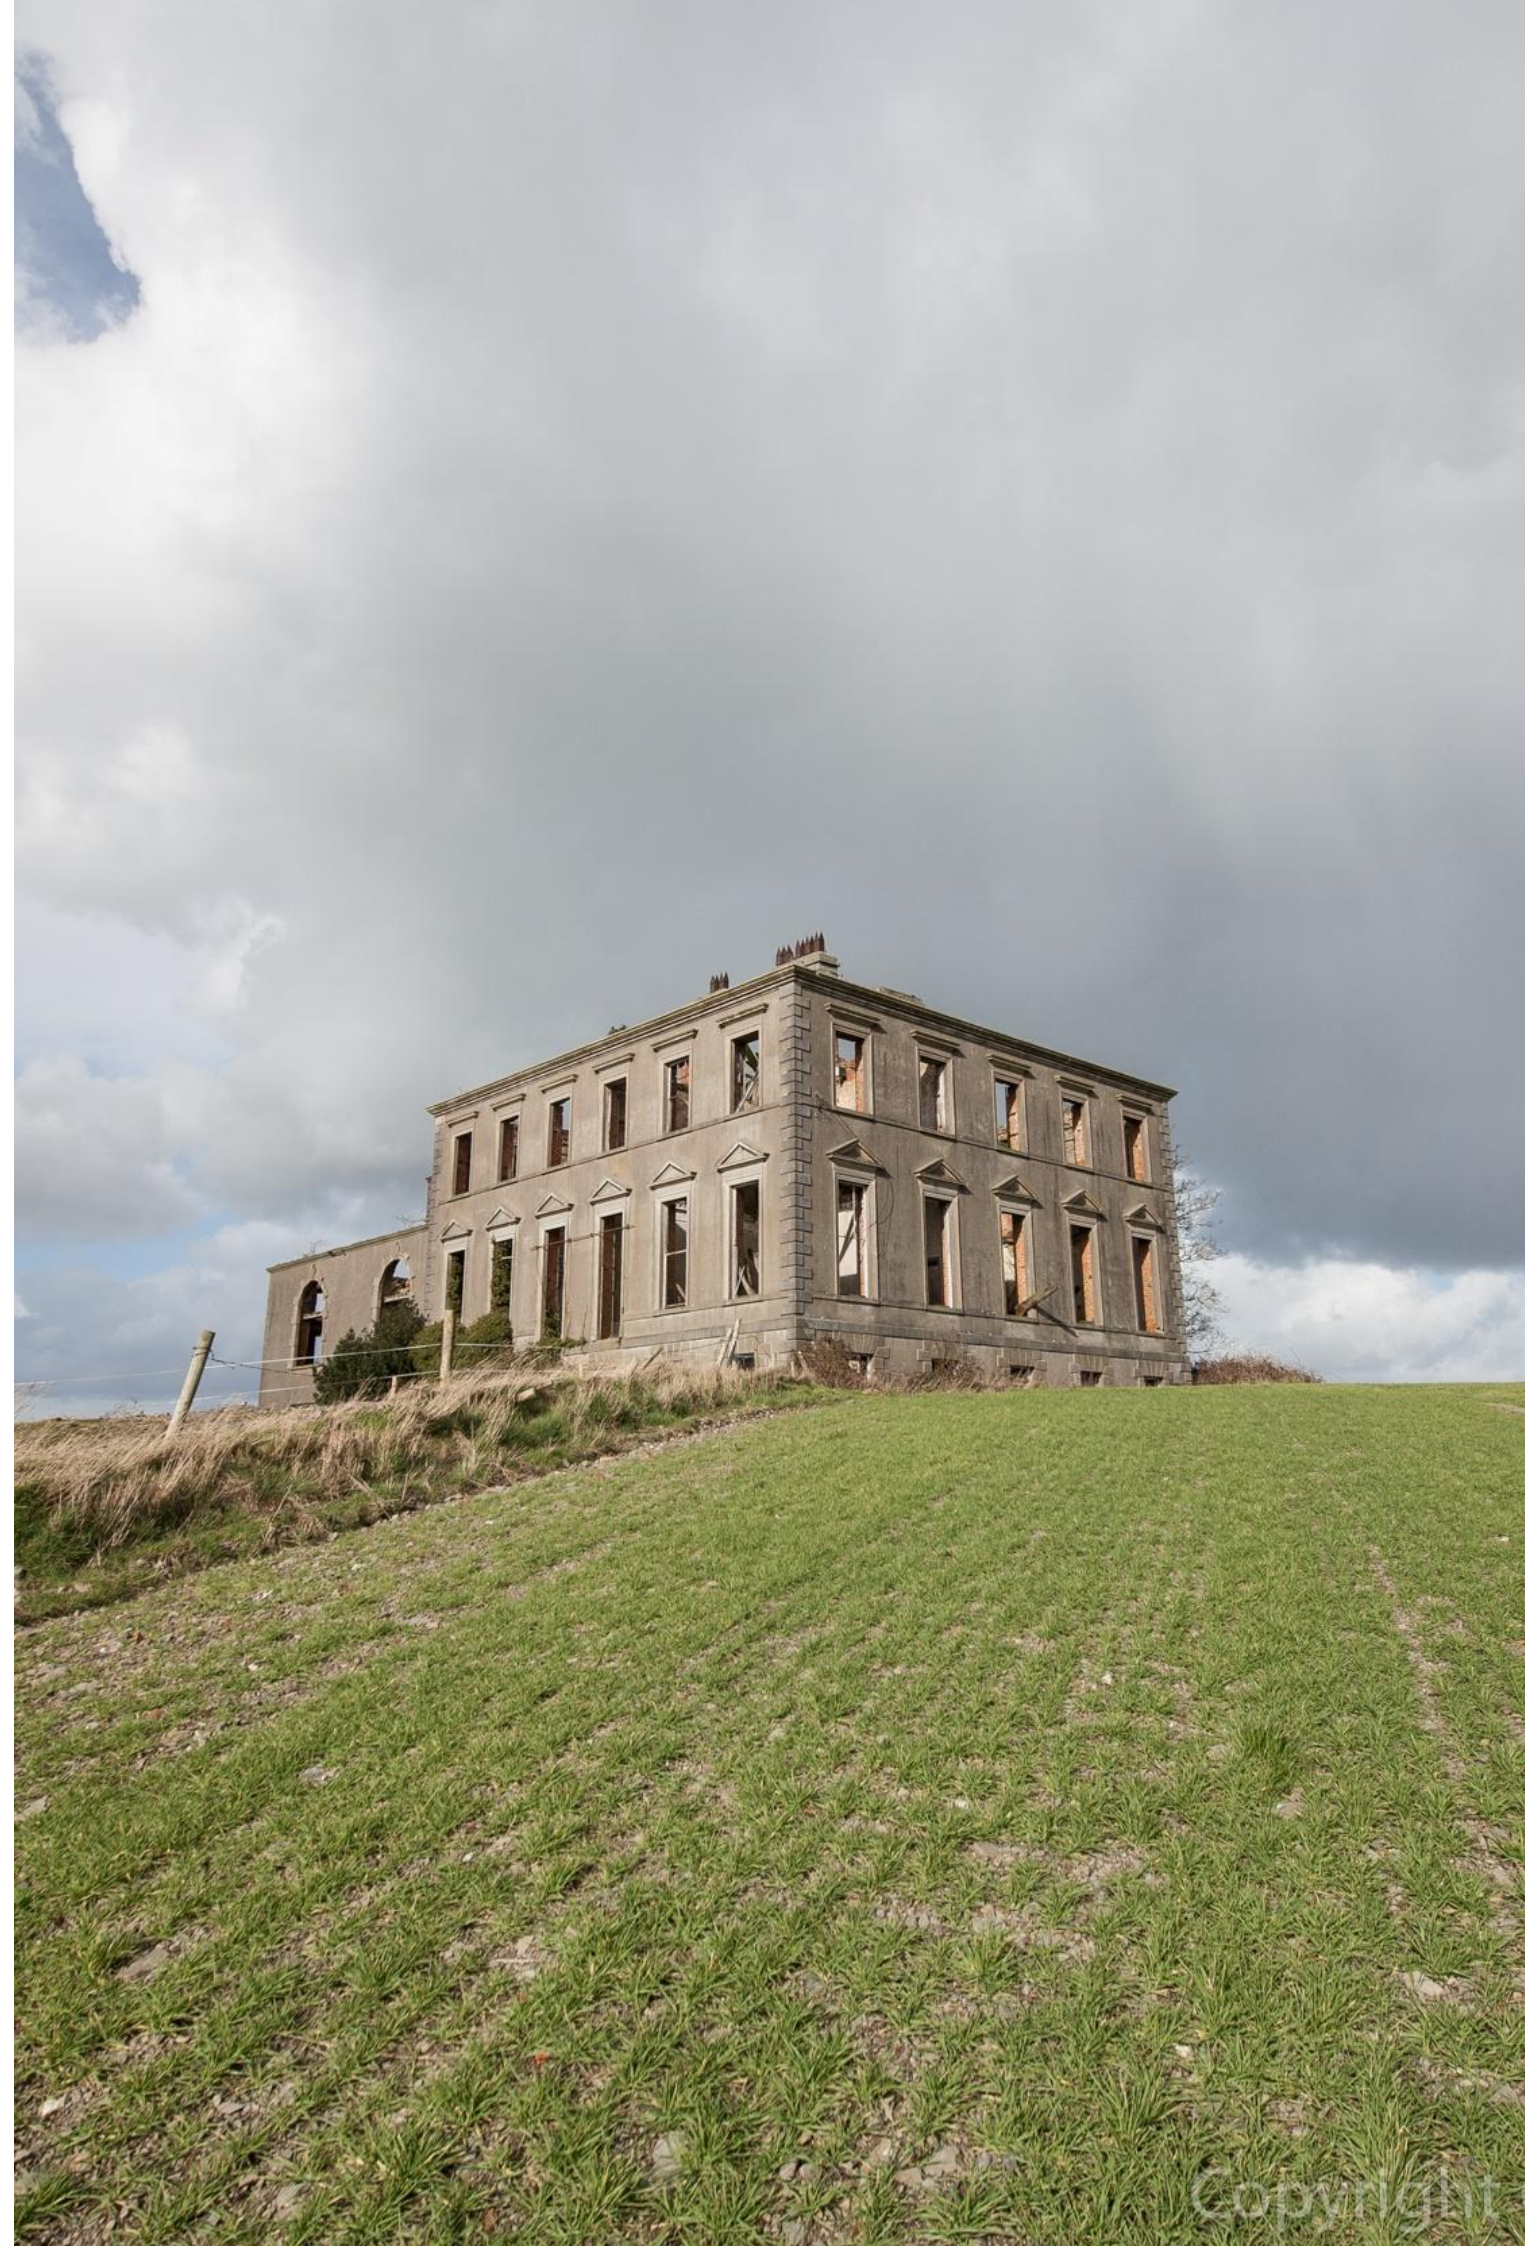
Glyde Court

Vacant with no identified new use	
Suffering from neglect and/or poor maintenance	X
Suffering from structural problems	
Fire damaged	
Threatened with demolition	
Ruin which is poorly maintained	X

Condition of Structure	Ruinous
Level of Risk	High

The building is a roofless shell. None of the original fabric remains other than the external walls. It is suffering from structural problems that could lead to full or partial collapse, and there is an immediate threat of further deterioration.

A late 18th century house with 19th century alterations and extensions in Jacobean style built for the Foster Family. The structure is of significant historic importance and requires conservation works to prevent further deterioration.

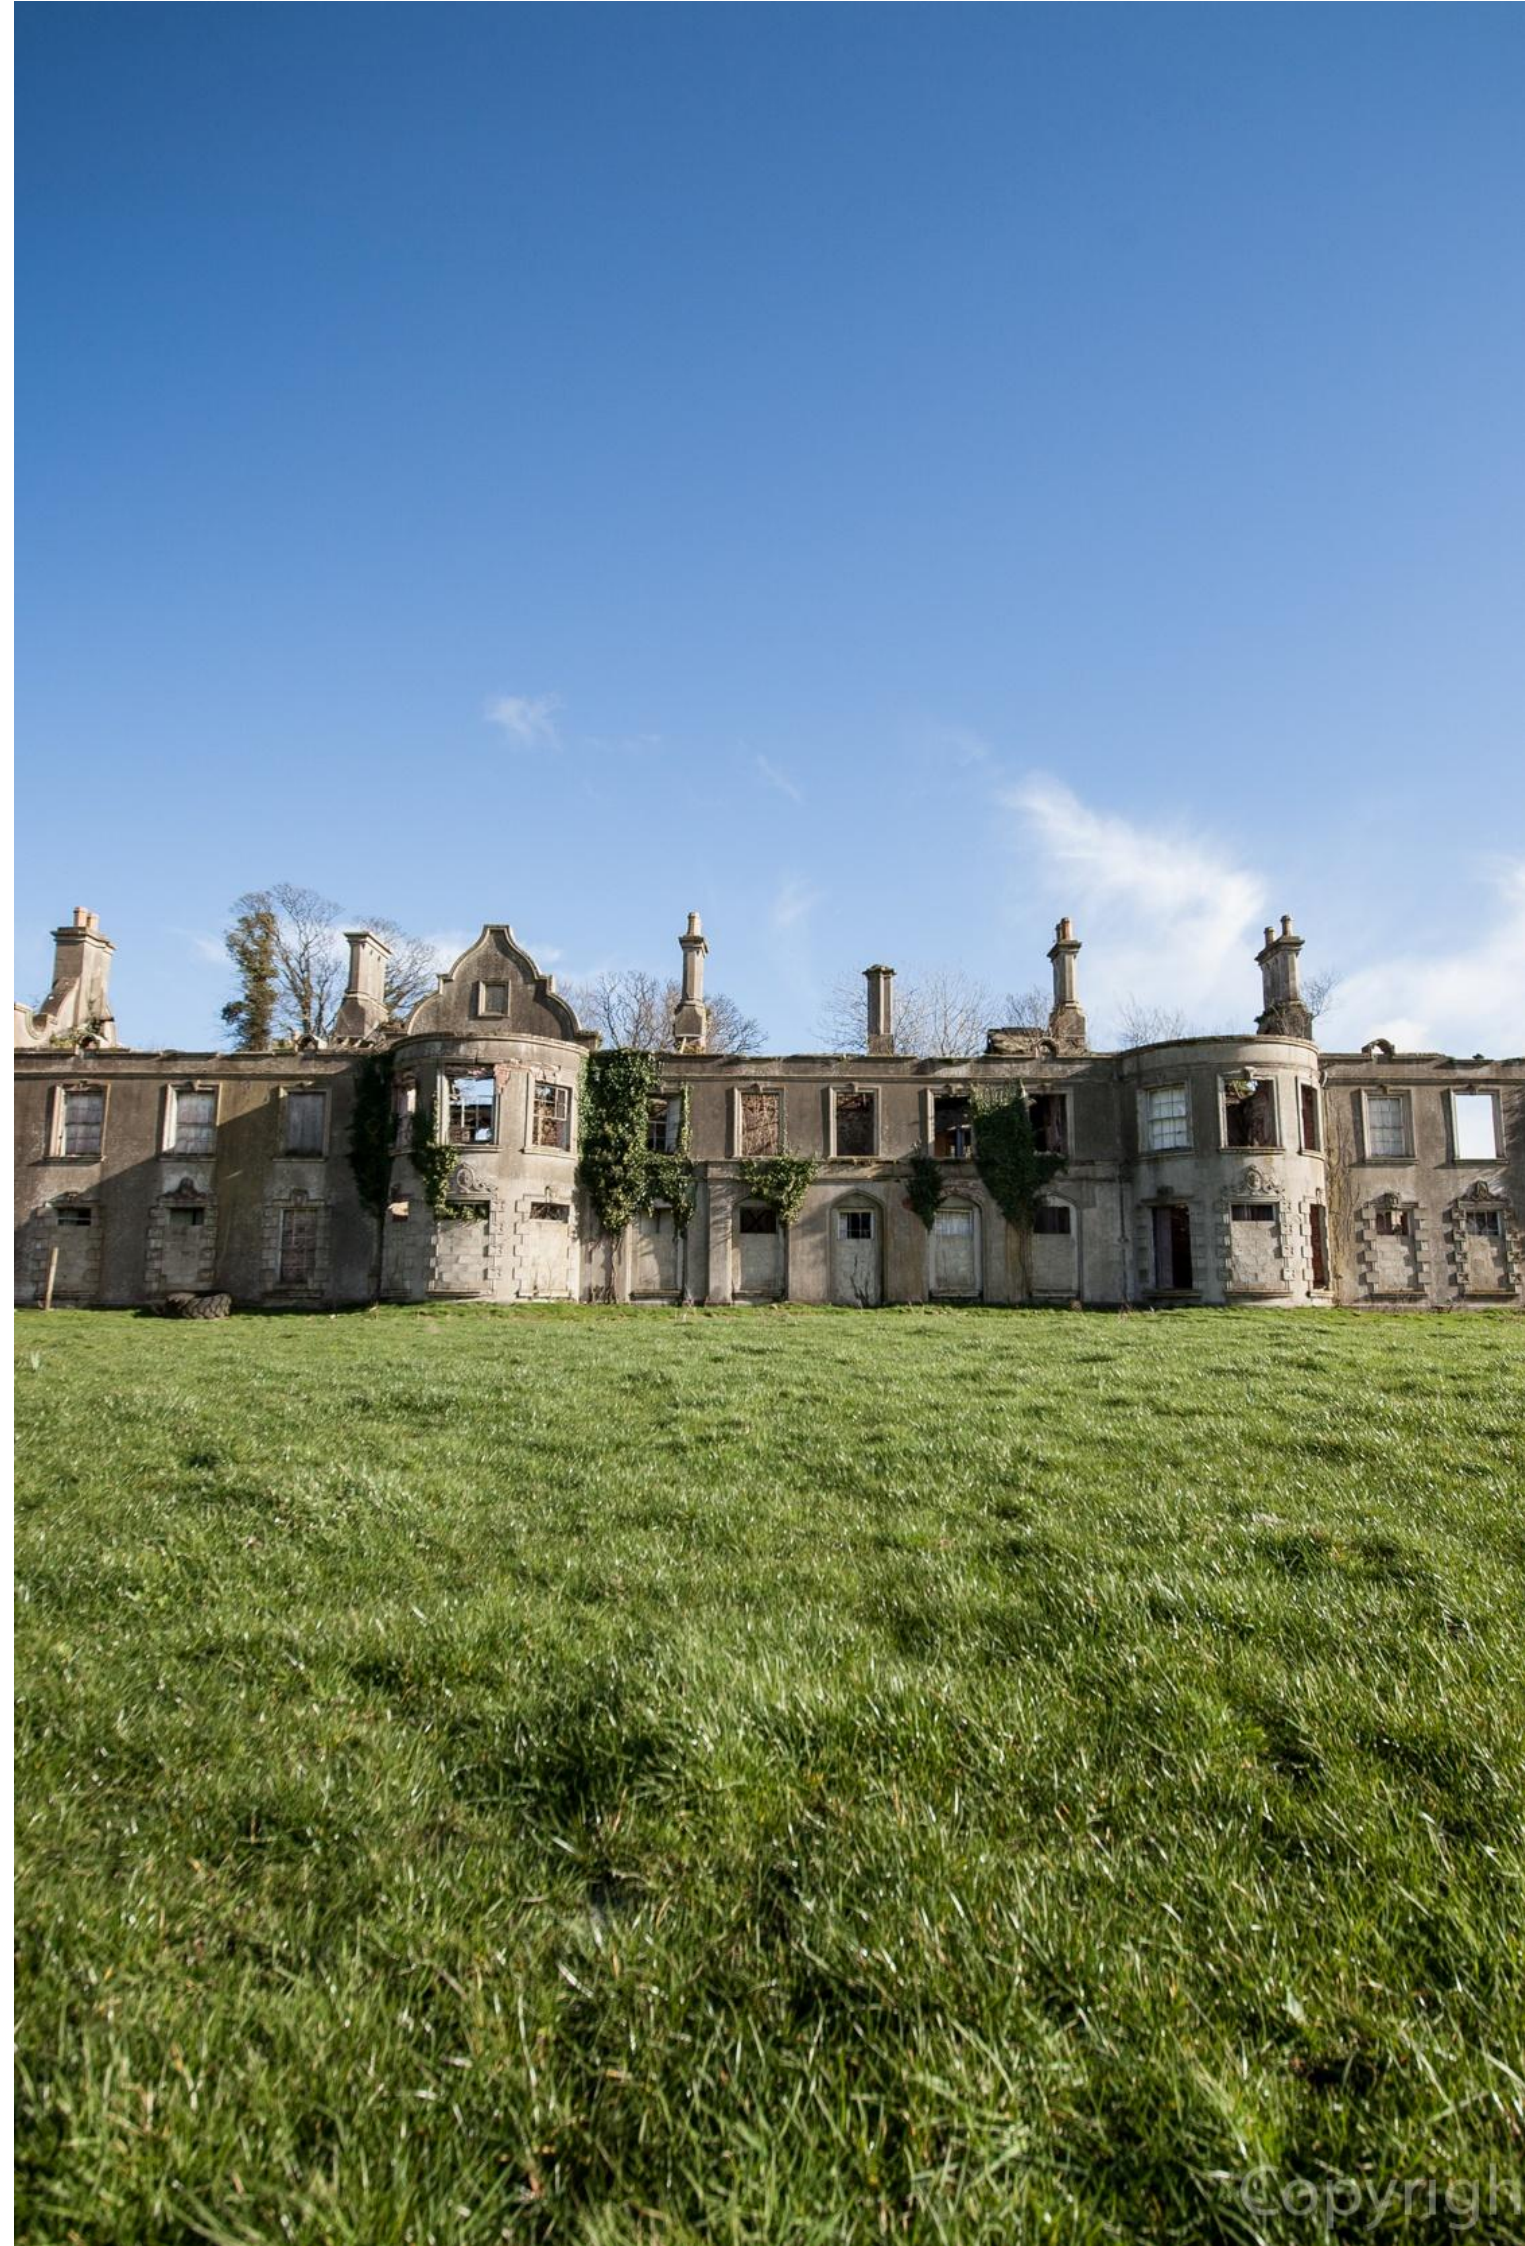
Vacant with no identified new use	
Suffering from neglect and/or poor maintenance	X
Suffering from structural problems	
Fire damaged	X
Threatened with demolition	
Ruin which is poorly maintained	X

Condition of Structure	Ruinous
Level of Risk	High

The building is a roofless shell. None of the original fabric remains other than the external walls. It is suffering from structural problems that could lead to full or partial collapse, and there is an immediate threat of further deterioration.

Louth Hall is a medieval tower with substantial mid 18th century house added by the Plunkett Family and abandoned in the mid 20th century. It became neglected and fire damaged which resulted in it turning to its current shell state. The structure is of significant historic importance and requires conservation works to prevent further deterioration.

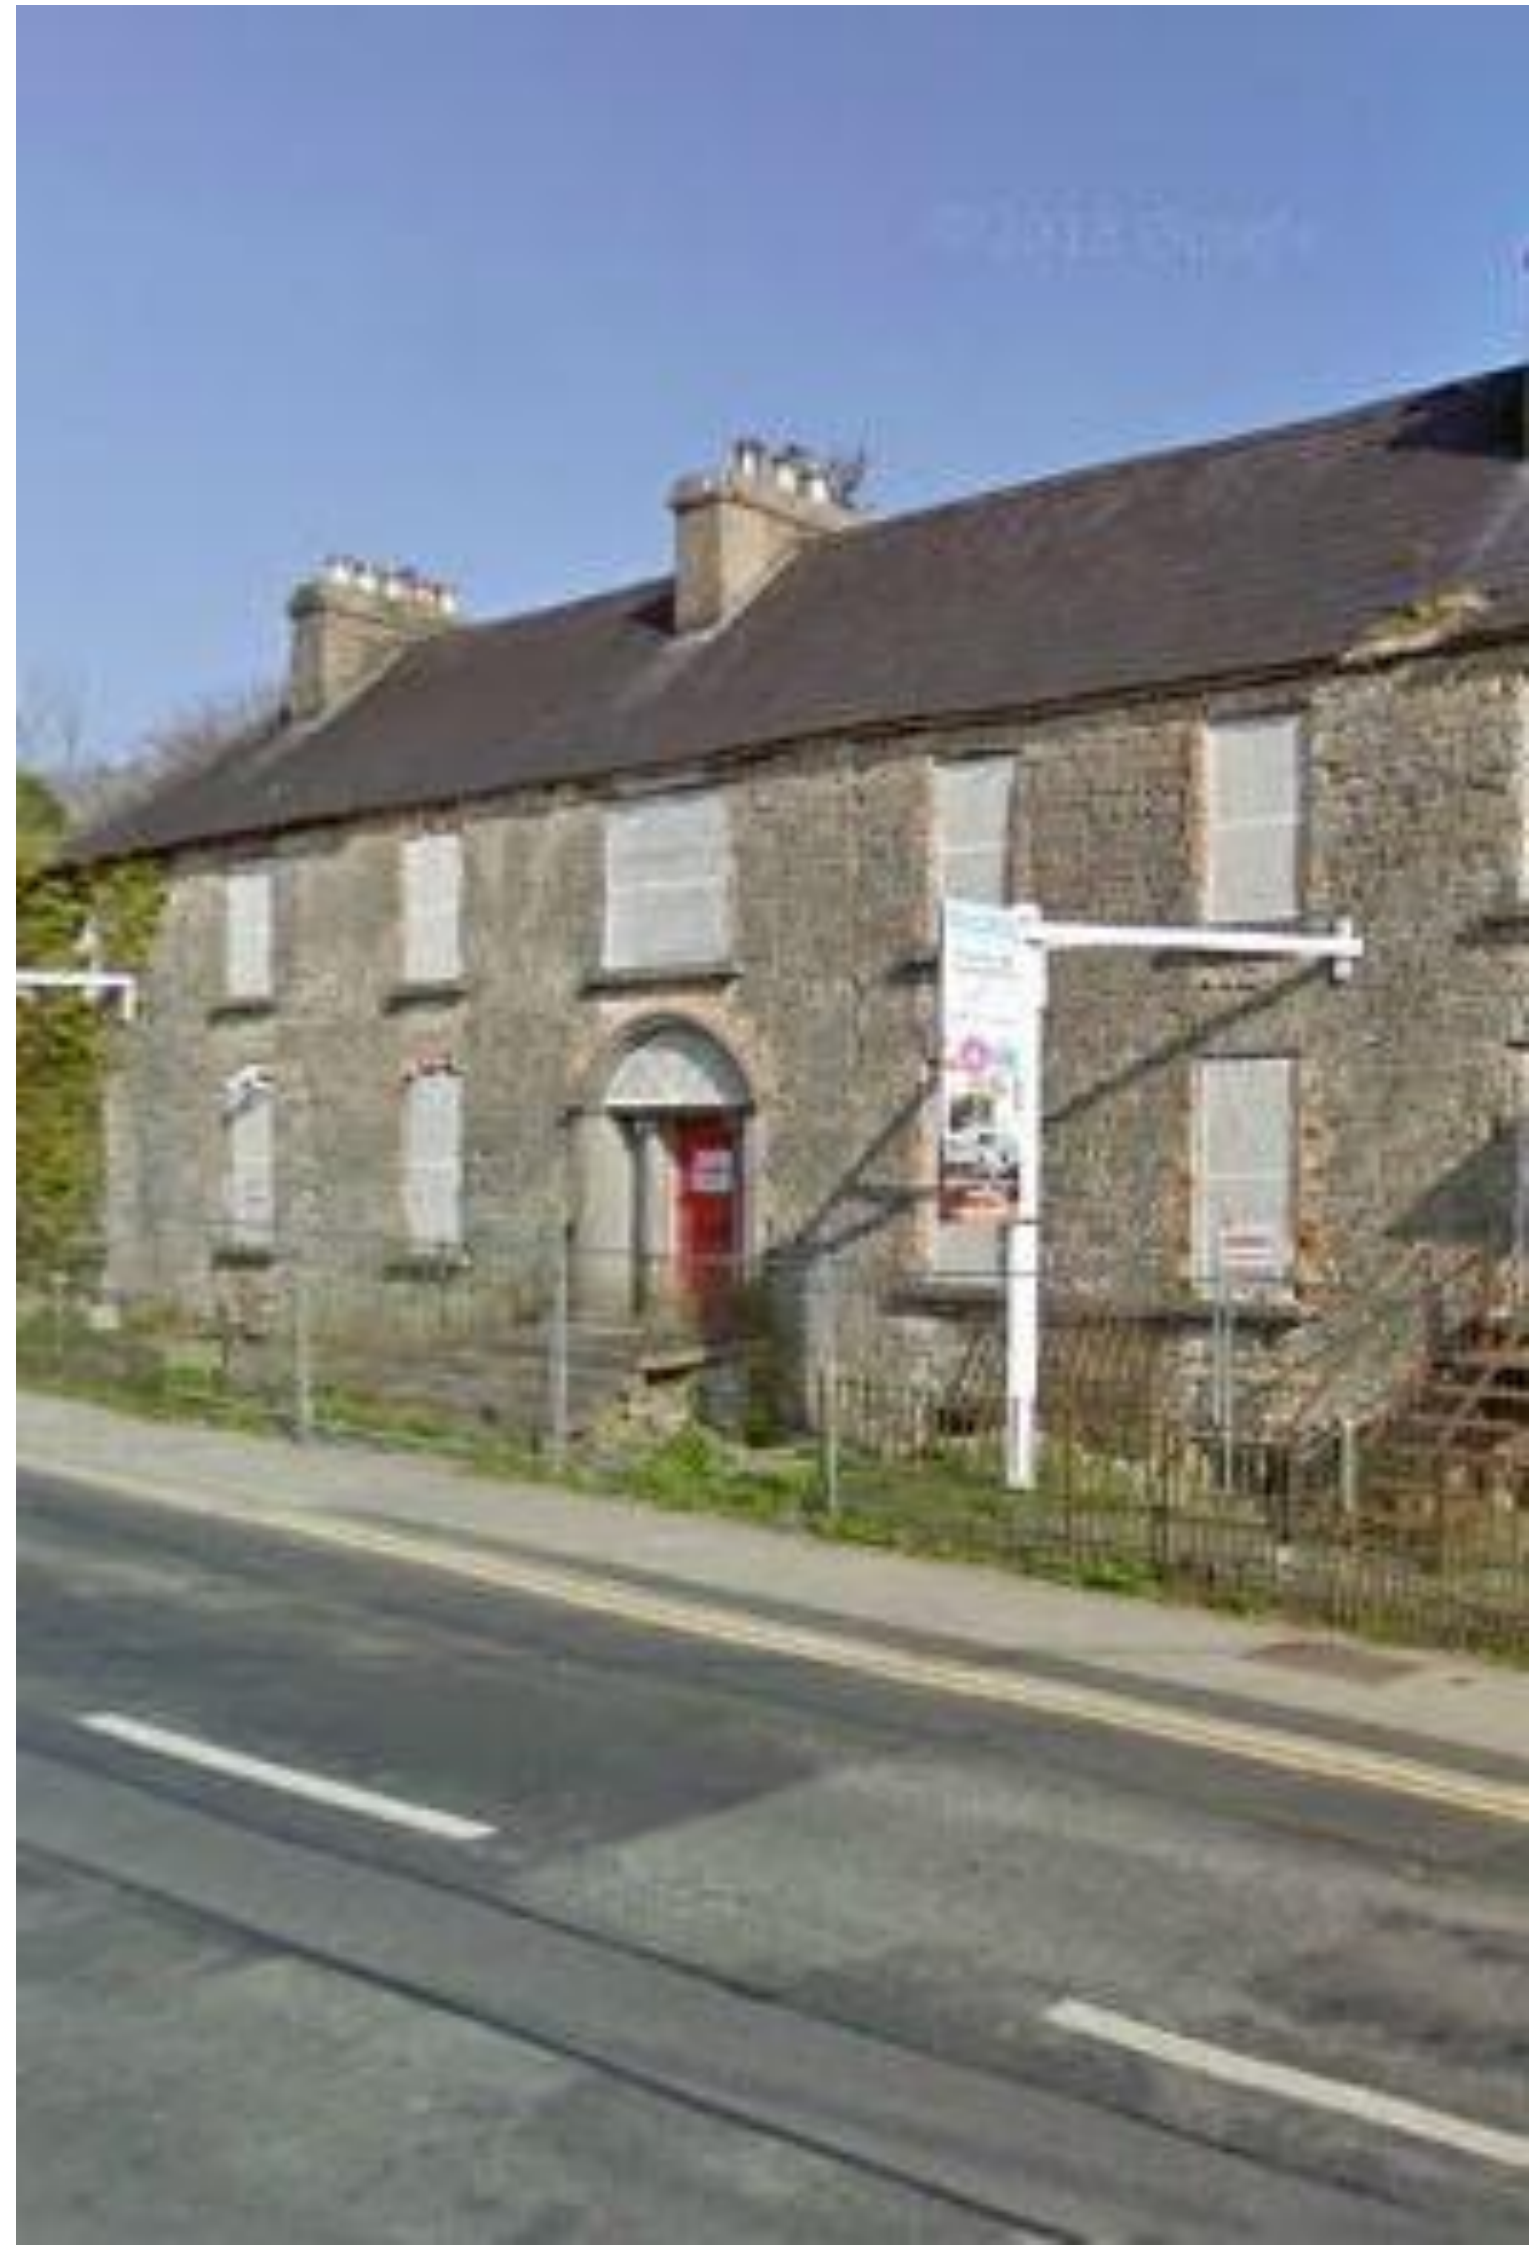
Moore Hall

Vacant with no identified new use	
Suffering from neglect and/or poor maintenance	X
Suffering from structural problems	
Fire damaged	X
Threatened with demolition	
Ruin which is poorly maintained	X

Condition of Structure	Ruinous
Level of Risk	High

The building is a roofless shell. None of the original fabric remains other than the external walls. It is suffering from structural problems that could lead to full or partial collapse, and there is an immediate threat of further deterioration.

A shell of a house built in the 1790s by George Henry Moore in a demesne by Lough Carra. It is the childhood home of writer George Moore. It was burned down in the Civil War in 1923. It now forms part of a Coillte landholding. The proposals to restore house have proved unviable. The structure is of significant historic importance and requires conservation works to prevent further deterioration.

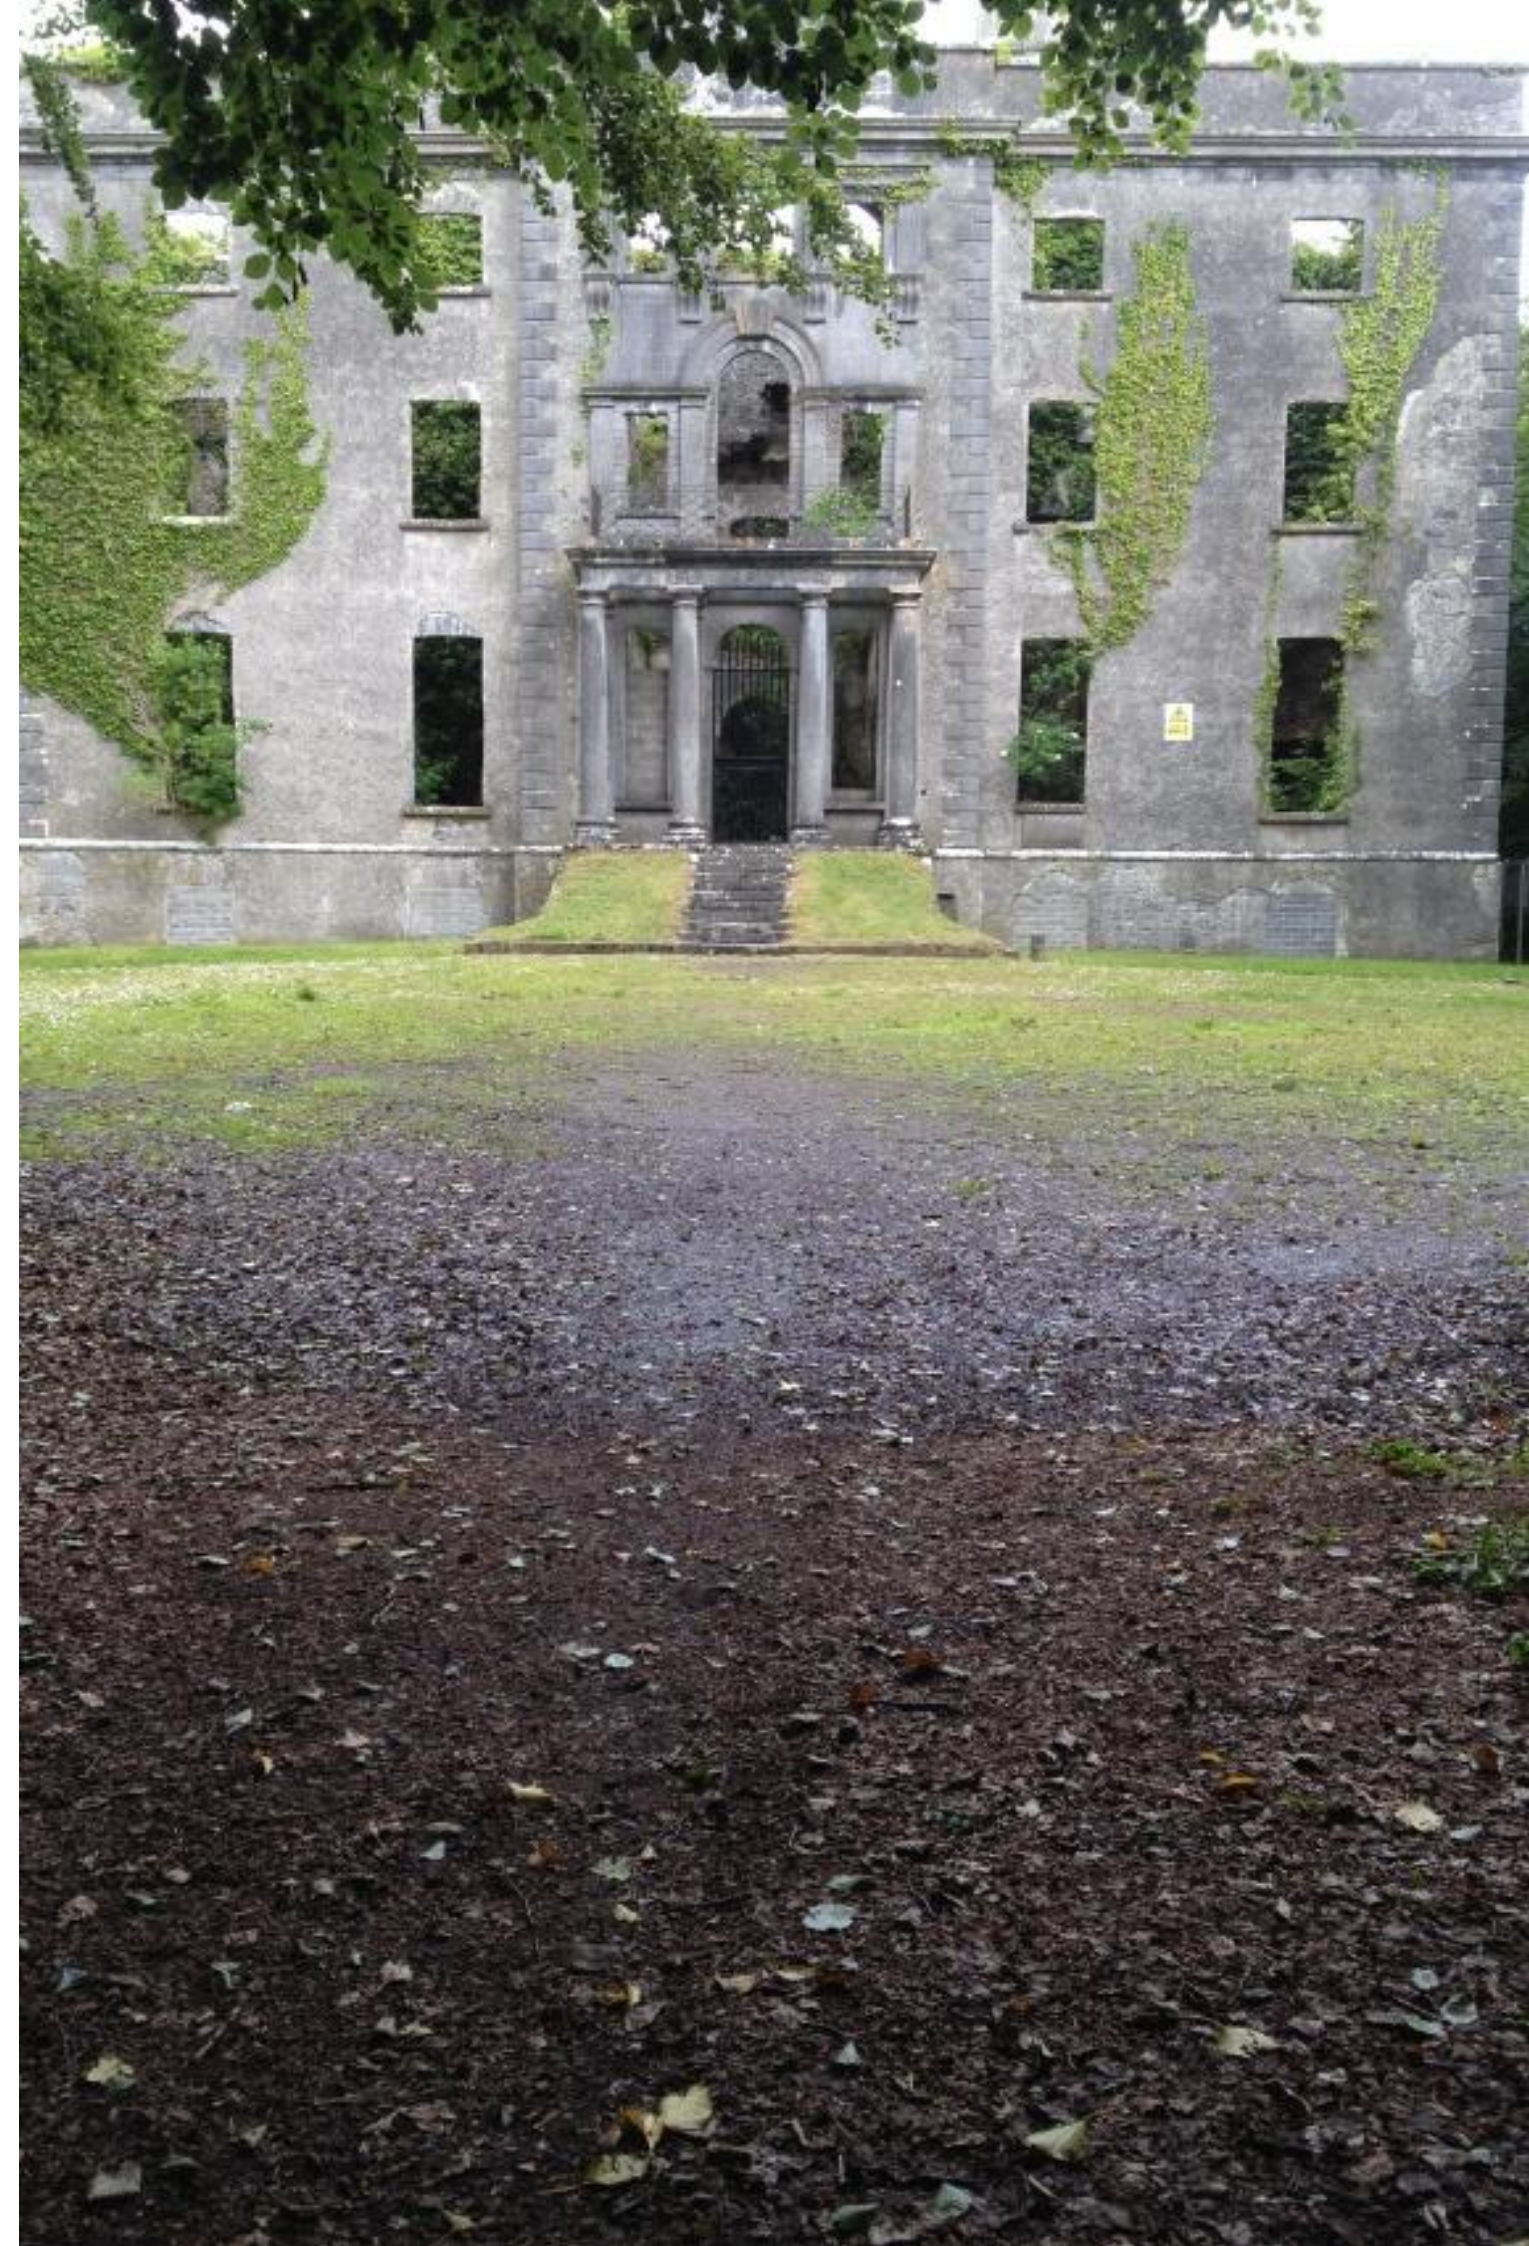
Castle MacGarret

Vacant with no identified new use	X
Suffering from neglect and/or poor maintenance	X
Suffering from structural problems	X
Fire damaged	
Threatened with demolition	
Ruin which is poorly maintained

Condition of Structure	Poor
Level of Risk	High

This building has been vacant for a number of years and does not appear to be maintained. Most of the external fabric remains, but there are obvious signs of deterioration, particularly water penetration, slipped slates, vegetation growth, broken windows and vandalism. There is no immediate danger of collapse but the condition is such that unless urgent remedial works are carried out the building will sharply deteriorate.

The house belonging to the Browne Family was constructed near an earlier castle close to the Robe River. The house was substantially rebuilt in early 20th century with fine neo-classical drawing room. The building was in use as a nursing home for most of 20th century with extensive additions. It is now vacant and urgently requires new uses to be identified to prevent further deterioration of its character.
